SAF/10/025

Safety Alert

Incident Involving MEWP Fire

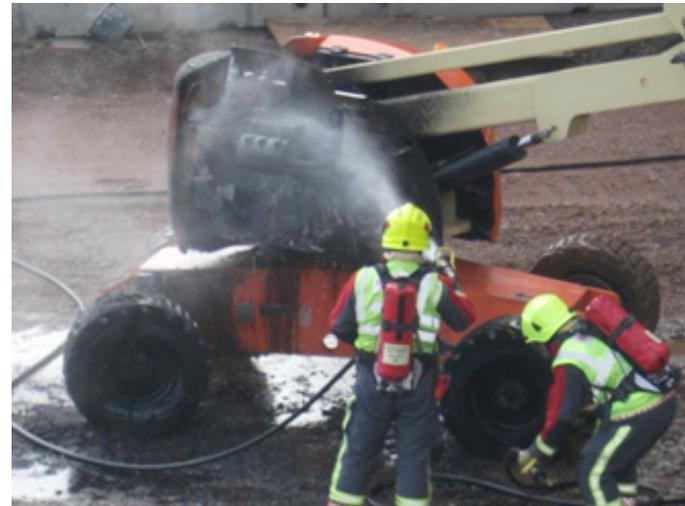
The operator was working at an approximate height of 5m when the fire started on the engine side of the 'base unit'. Other operatives noticed the fire and attracted the operator's attention who immediately started to lower the basket. After lowering the basket approximately 2m, the MEWP cut out and the operator was unable to bring it down on auxiliary power, (most likely because the battery was badly damaged by the fire). The fire also meant that no one could reach the emergency descent controls.

Left with little choice, the operator climbed over the guardrails and dropped to the ground – a distance of approximately 1.5m. He was not hurt.

1. The MEWP was defective in so much that it seems probable there was a leak of fuel or oil in the engine compartment. **PLEASE NOTE: 'NO' daily plant inspection form was completed for the MEWP nor had one been completed previously.**
2. The Risk Assessment stated that a designated ground man must be in place during all operations of a cherry picker. This wasn't implemented and so the detection of the fire and subsequent rescue of the operator was delayed.

1. All elements of the risk assessments for working at height are being implemented – and if circumstances require a Ground Man to be deployed, that this person is adequately trained.
2. A dry powder fire extinguisher is available in case of an emergency.
3. Daily inspections are completed for all MEWPs including those operated by sub-contractors.
4. A plan for carrying out an emergency rescue is in place and tested regularly.

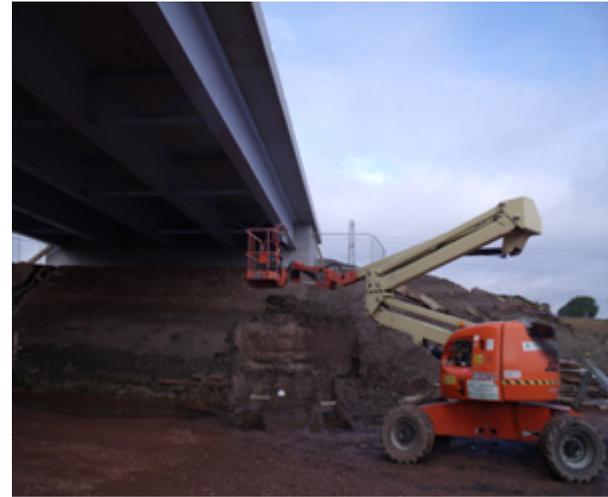
The main implication of this incident is the safety of the occupants in a MEWP basket should a base unit catch fire in the future. If the occupant was higher in the air, or perhaps working over water for example, the outcome could have been very different. The recommendations are therefore to prevent a reoccurrence of this incident rather than address evacuation procedures.
