Hand Injury, Mobil Taupo- FAI

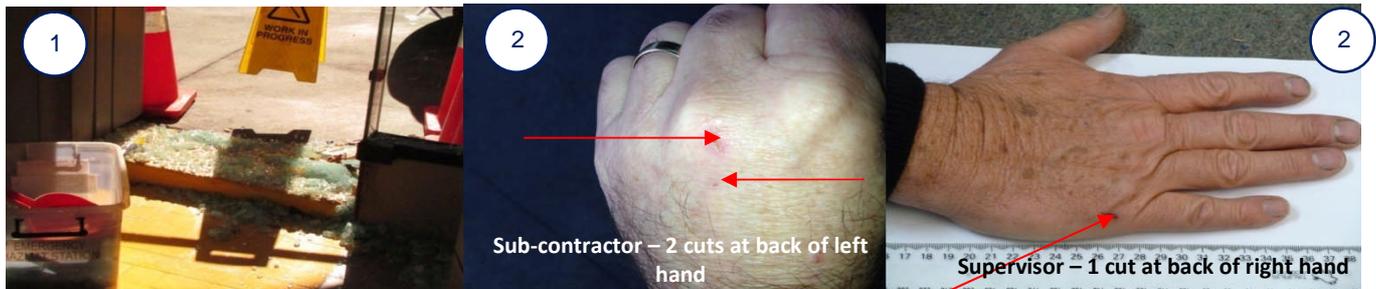
Description: On Saturday 12th May 2012, 11:32, two technicians (a supervisor & a sub-contractor) were servicing the auto door and in the process of repositioning (vertical lift of 100 mm) the tempered frameless glass door panel, it shattered⁽¹⁾. The two service technicians holding the panel were not wearing hand protection and both of them received minor cuts to both their hands⁽²⁾. The wounds were cleaned and common Band Aids were applied to the cuts. No other medical assistance was required. The incident was notified to contractor management and JCI immediately. The work area was made safe and cleaned up. JCI followed up with the injured technicians and confirm they did not require any further treatment to their hands. This incident was classified as a First Aid Incident.

Condition of the shattered glass

Cuts to the back of the technicians' hands

- 1e) Job was sub-contracted to a local electrical contractor and not a glazier, who was not specialized in handling glass
- 5b) Task specific JSA was available at site, but did not address the hazard of glass slipping and shattering
- 4e) Did not wear gloves as risk of glass shattering was not considered prior to commencement of work

- 1e) Task completed/attempted by non-qualified person
 - The electrician was not trained on lifting glass doors
- 5b) Procedure content did not address the potential hazards associated with the task
 - Non slip gloves were not specified in JSA
 - The risk of the glass shattering risk was not considered
- 4e) Lack of understanding of SH&E risks associated with task

- 1e) Contractor management to ensure all works are assigned to qualified personnel/sub-contractor, in particular working in remote locations
- 5b) Update JSA to reflect the hazards of glass breaking or shattering
Update JSA to reflect hazards of glass breaking /shattering and slipping during handling
Prescribe the use non-slip gloves when handling glass
- 4e) Conduct refresher training on risk assessment when handling glass
