# What Would Good Have Looked Like 35 DAMAGED FENCE PANELS

ExxonMobil

April 2014

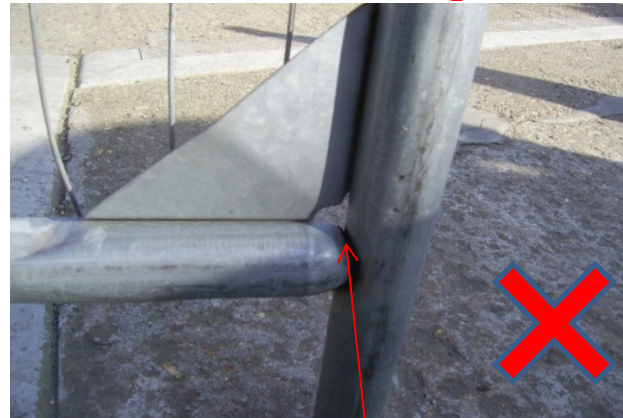
During recent high winds a Haras type fence panel that was part of the main perimeter fence line was damaged, the weld in the top corner broke causing the panel to become unstable and not fit for purpose, the weld damage was not apparent

- ✓ Inspect all fencing daily, including welds & fixings.
- ✓ Can we use an alternative fence type with rounded corners to reduce the weak points?
- ✓ Check the weather conditions and ensure the fencing is secure.
- ✓ Remove debris netting and signage to reduce the risk of being blown over by strong winds.
- ✓ Carry out your SPSA before leaving site.

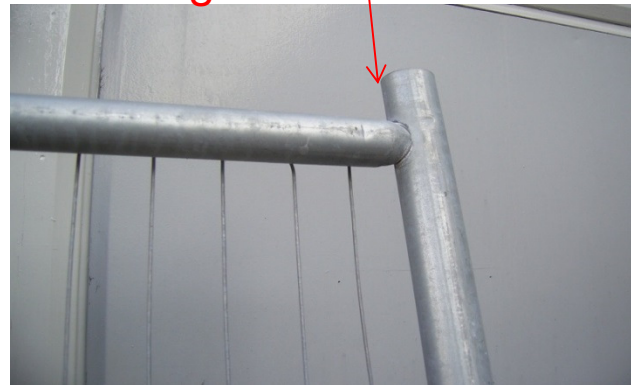
Damaged weld
