What Would Good Have Looked Like? Tank Fire from Vapours in Slurried Tank

ExxonMobil

— **Environmental Services**

August 2012

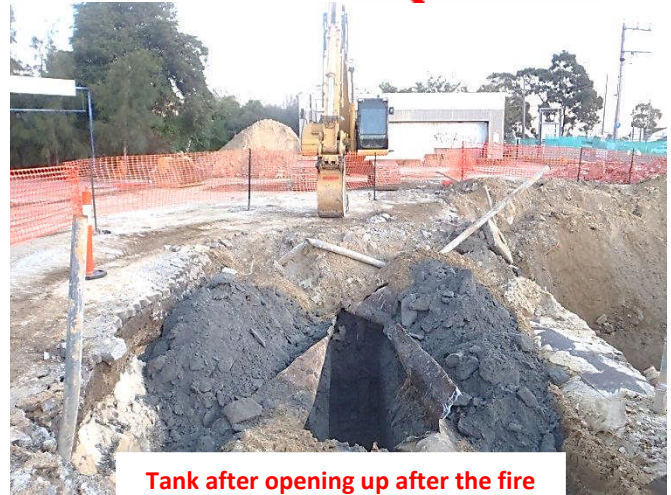
- During removal of a slurry filled tank, a small fire occurred as the excavator cutting equipment made a hole in the tank.
- In making the hole larger to pump out the liquid on top of the slurry inside the tank, a spark/or heat from metal on metal caused the vapours from the tank to ignite .
- Conducted LEL testing around the tank pit, but not at the tank opening or within.

Tank after opening up after the fire

- ✓ Procedures & JSAs need to reflect the potential for voids containing flammable vapour in all slurried tanks
- ✓ Confirm **Supervisor Qualifications/Experience**

- ✓ Establish how to reduce elevated LEL levels within the tank – plan for **inerting the voids** with Dry ice, nitrogen or foam, or flush with water until the LEL exposure is removed

- ✓ Use extension wands or flexible tubing to measure LEL and Oxygen levels inside the tank at all of the tank openings
