DOUNREAY SHE ALERT

Ref: 12_02_A(D)

POTENTIAL ASBESTOS EXPOSURE DUE TO NOTICE BOARD REMOVAL

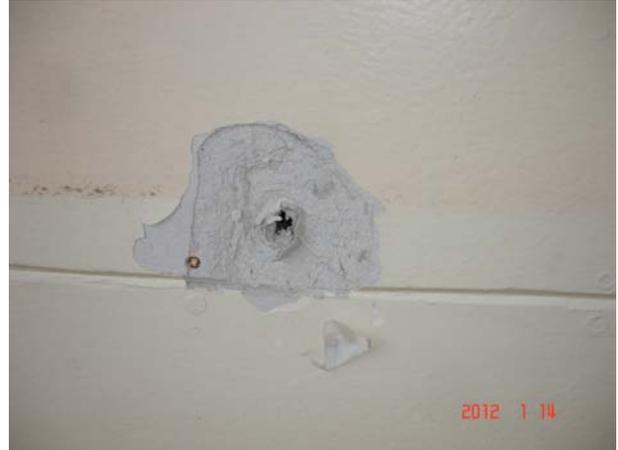
On the Saturday a Supervisor was passing outside the area and due to his previous experience as an Asbestos Operative, noted a breach of the asbestos wall. He immediately took the necessary action to have the area isolated and the relevant parties informed. The Supervisor should be commended for his vigilance and prompt action.

An asbestos Demolition Survey had been completed and a number of Asbestos Insulating Board (AIB) walls had been identified and labelled accordingly.

The method statement for the task stated that the Notice Boards were to be removed. The MS also stated that "asbestos surveys were completed in each of the offices and confirm that there are no asbestos issues associated with this work". The MS was therefore inadequate for the task as it did not identify the asbestos hazards that were present.

A walkround was conducted by the Project Engineer, Facility Supervisor and Operative to discuss the work package. Areas where asbestos had been identified or presumed were discussed. However, neither the Facility Supervisor nor the Operative recalls any specific mention that the notice board, attached to an AIB wall, should not be removed. Therefore, it can be concluded that the verbal discussion was an inadequate control measure.

An asbestos warning label was on the wall but the Operator did not apply the START principle and continued with removal of the notice board even though it was obvious an asbestos hazard existed.

The area is to be cleaned by a Licensed Contractor before work recommences. Examination of the Regulations has also determined that the incident is not RIDDOR reportable.

- Method Statements and Pre-job Briefs must adequately identify the hazards present and clearly identify the work which is to be completed and that which is not to be completed.
- Operatives must never disregard asbestos warning signs and undertake work which will damage or disturb asbestos containing materials.
- Operatives must apply the START principle when faced with a situation that introduces new hazards which have not been identified.
- Operatives who are likely to come across asbestos during their working activities should attend the DSRL Asbestos Awareness training and relevant refresher.
