HSE 2012  
March 07, 2012

### Carry Deck Crane Outrigger Smashes Worker's Foot

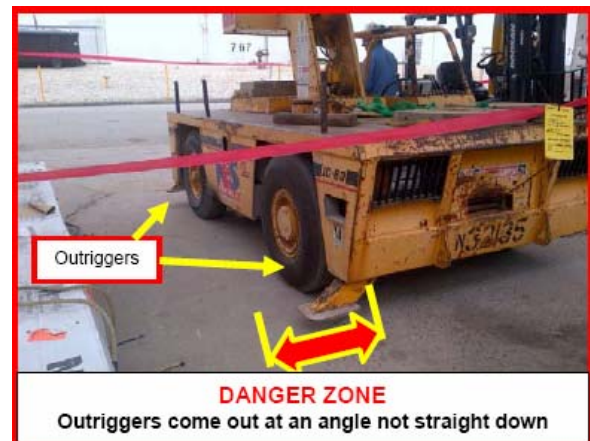
The rigger was standing at the right front of the carry deck crane, spotting for the crane operator as the carry deck crane was backed out of the unit. The rigger noticed the right rear outrigger was not fully retracted and alerted the operator.

The operator stopped and attempted to raise the outrigger, but in the process operated the wrong lever, resulting in the front outrigger being deployed down onto the rigger's right foot.

- The outrigger alarms sounded as the outriggers were lowered, so no malfunction of safety warning devices.
- The injured worker was wearing safety toed boots, which minimized the severity of the injury.
