# What Would Good Have Looked Like 35 DAMAGED FENCE PANELS

ExxonMobil

April 2014

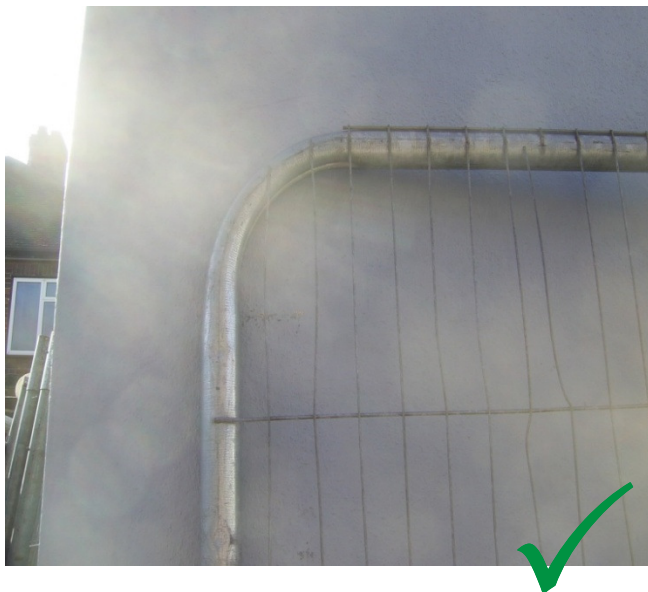
During recent high winds a Haras type fence panel that was part of the main perimeter fence line was damaged, the weld in the top corner broke causing the panel to become unstable and not fit for purpose, the weld damage was not apparent

The panel could have fallen over injuring an operative.

There could have been a security breach.

- ✓ Inspect all fencing daily, including welds & fixings.
- ✓ Can we use an alternative fence type with rounded corners to reduce the weak points?
- ✓ Check the weather conditions and ensure the fencing is secure.
- ✓ Remove debris netting and signage to reduce the risk of being blown over by strong winds.
- ✓ Carry out your SPSA before leaving site.
