SAFETY ALERT: FIRST AID INCIDENT (FAI), HAND INJURY, PAPATOETOE, NZ

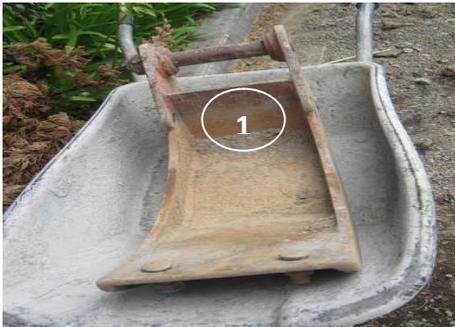
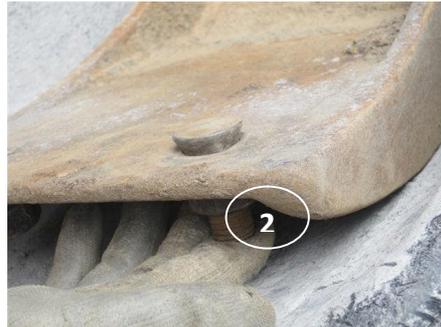
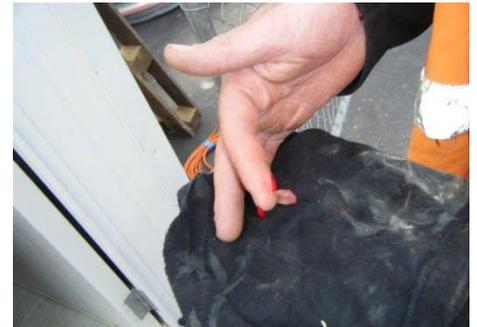
Description: The driver of a small excavator requested that the spotter and labourer use a wheel barrow to collect an alternative spade adaptor¹ for the excavator. They then lifted the excavator spade attachment (approx 40KG) into a wheelbarrow to transfer it over to the excavator. On lowering the attachment into the wheelbarrow, one of the technician's fingers got caught in between a loose bolt on the excavator spade attachment and the wheelbarrow². When he felt the weight of the spade attachment pressing on his finger, he reacted instinctively and quickly pulled out his hand and in doing so it scraped a layer of skin off his finger through the glove. The use of gloves rated 4543 by both individuals significantly reduced the extent of this injury. First aid was provided on site by the site supervisor who cleaned the wound and dressed it up with an adhesive plaster.

- Conduct refresher training on correct interchange of excavator's attachment e.g. spade or others
- Conduct refresher coaching on-site regarding pre-job planning and identification of all equipment required

- Conduct refresher on always using last minute risk assessment including when following request from peer

- Conduct refresher for all construction site workers on hazard identification and mitigation for site specific task

- additional time should be spent with the general contractor planning the works in advance including correct identification of equipment, conduct detailed hazard identification and identify alternate mitigation plans
- the use of mechanical lifting aids should have been considered and implemented on site
- it is essential to clearly communicate roles and responsibilities for all individuals on site to ensure everyone understand the escalation process in the event of queries or questionable decisions on site
- Complete a last minute risk assessment, stay focussed on the task at hand until completion and avoid any distractions
