ToolBox Talk 194

Faulty Excavator Boom

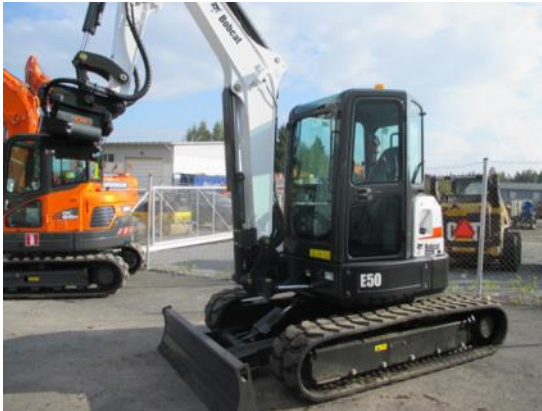
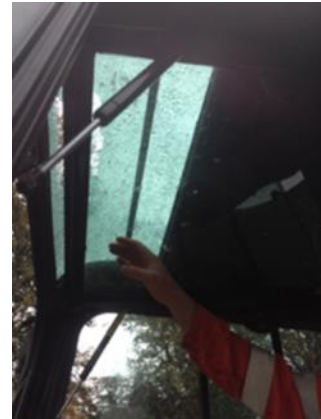
- Recently, a 5 tonne Bobcat E50 excavator was being operated onsite with an unknown fault. Whilst tracking with the boom in the upright position. The boom made contact with the cab resulting in the window in the roof shattering.

- At the time the front window was in the “up” position which prevented shattered glass hitting the driver
- Two small pieces of glass had been noted in the pre-work checks but a check of the windows had not been undertaken as the Esso Heavy Plant Check Sheet had not been used and not prompted the driver to check.
- Hire company had recently replaced the window but had not properly investigated the root cause. Pressure from hirer made the hire company investigate and realise the problem was due to the boom touching the cab. It is not possible to check for this without damaging the excavator.
- The excavator showed It was within its quarterly service schedule

- Always ensure that the Esso Heavy Plant Check list is used for pre-work checks as it prompts areas to be checked that may not be considered risks by plant operators.
- Feedback any mechanical issues to hire companies and insist on further investigations. This could avoid damage charges being applied.
