# What Would Good Have Looked Like - 33

## Lifting Augers on the Winch

ExxonMobil

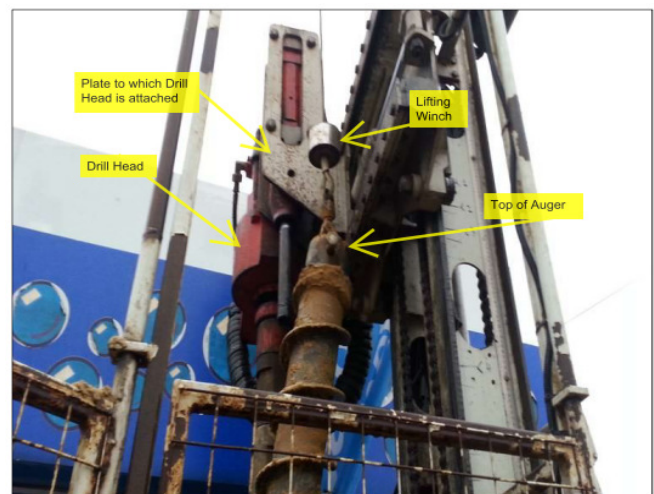
A driller removing hollow stem augers from a borehole was pushed in the chest by the augers as they were being winched from the completed borehole. The driller tripped backwards and fell but was not injured.

- The top of the auger caught on the drill head plate, causing the bottom of the auger to move outwards towards the driller.
- The drill head was not lifted up to its full height – causing an obstruction.
- 'Line of fire' risk was not identified through SPSA.

- SPSA by the driller or 2<sup>nd</sup> man could have prevented the incident from occurring.

- Although no rotation is taking place, keep the protective cage closed whenever hoisting augers on the winch.
- Second man to only open cage and access augers once lead driller has stopped working the winch.
- Lead driller to position the drill head to its full clearance height before starting the task in order to prevent the risk of the auger catching.
